Safety Alert

ALERT 09 – 36

DROPPED GENERATOR SET

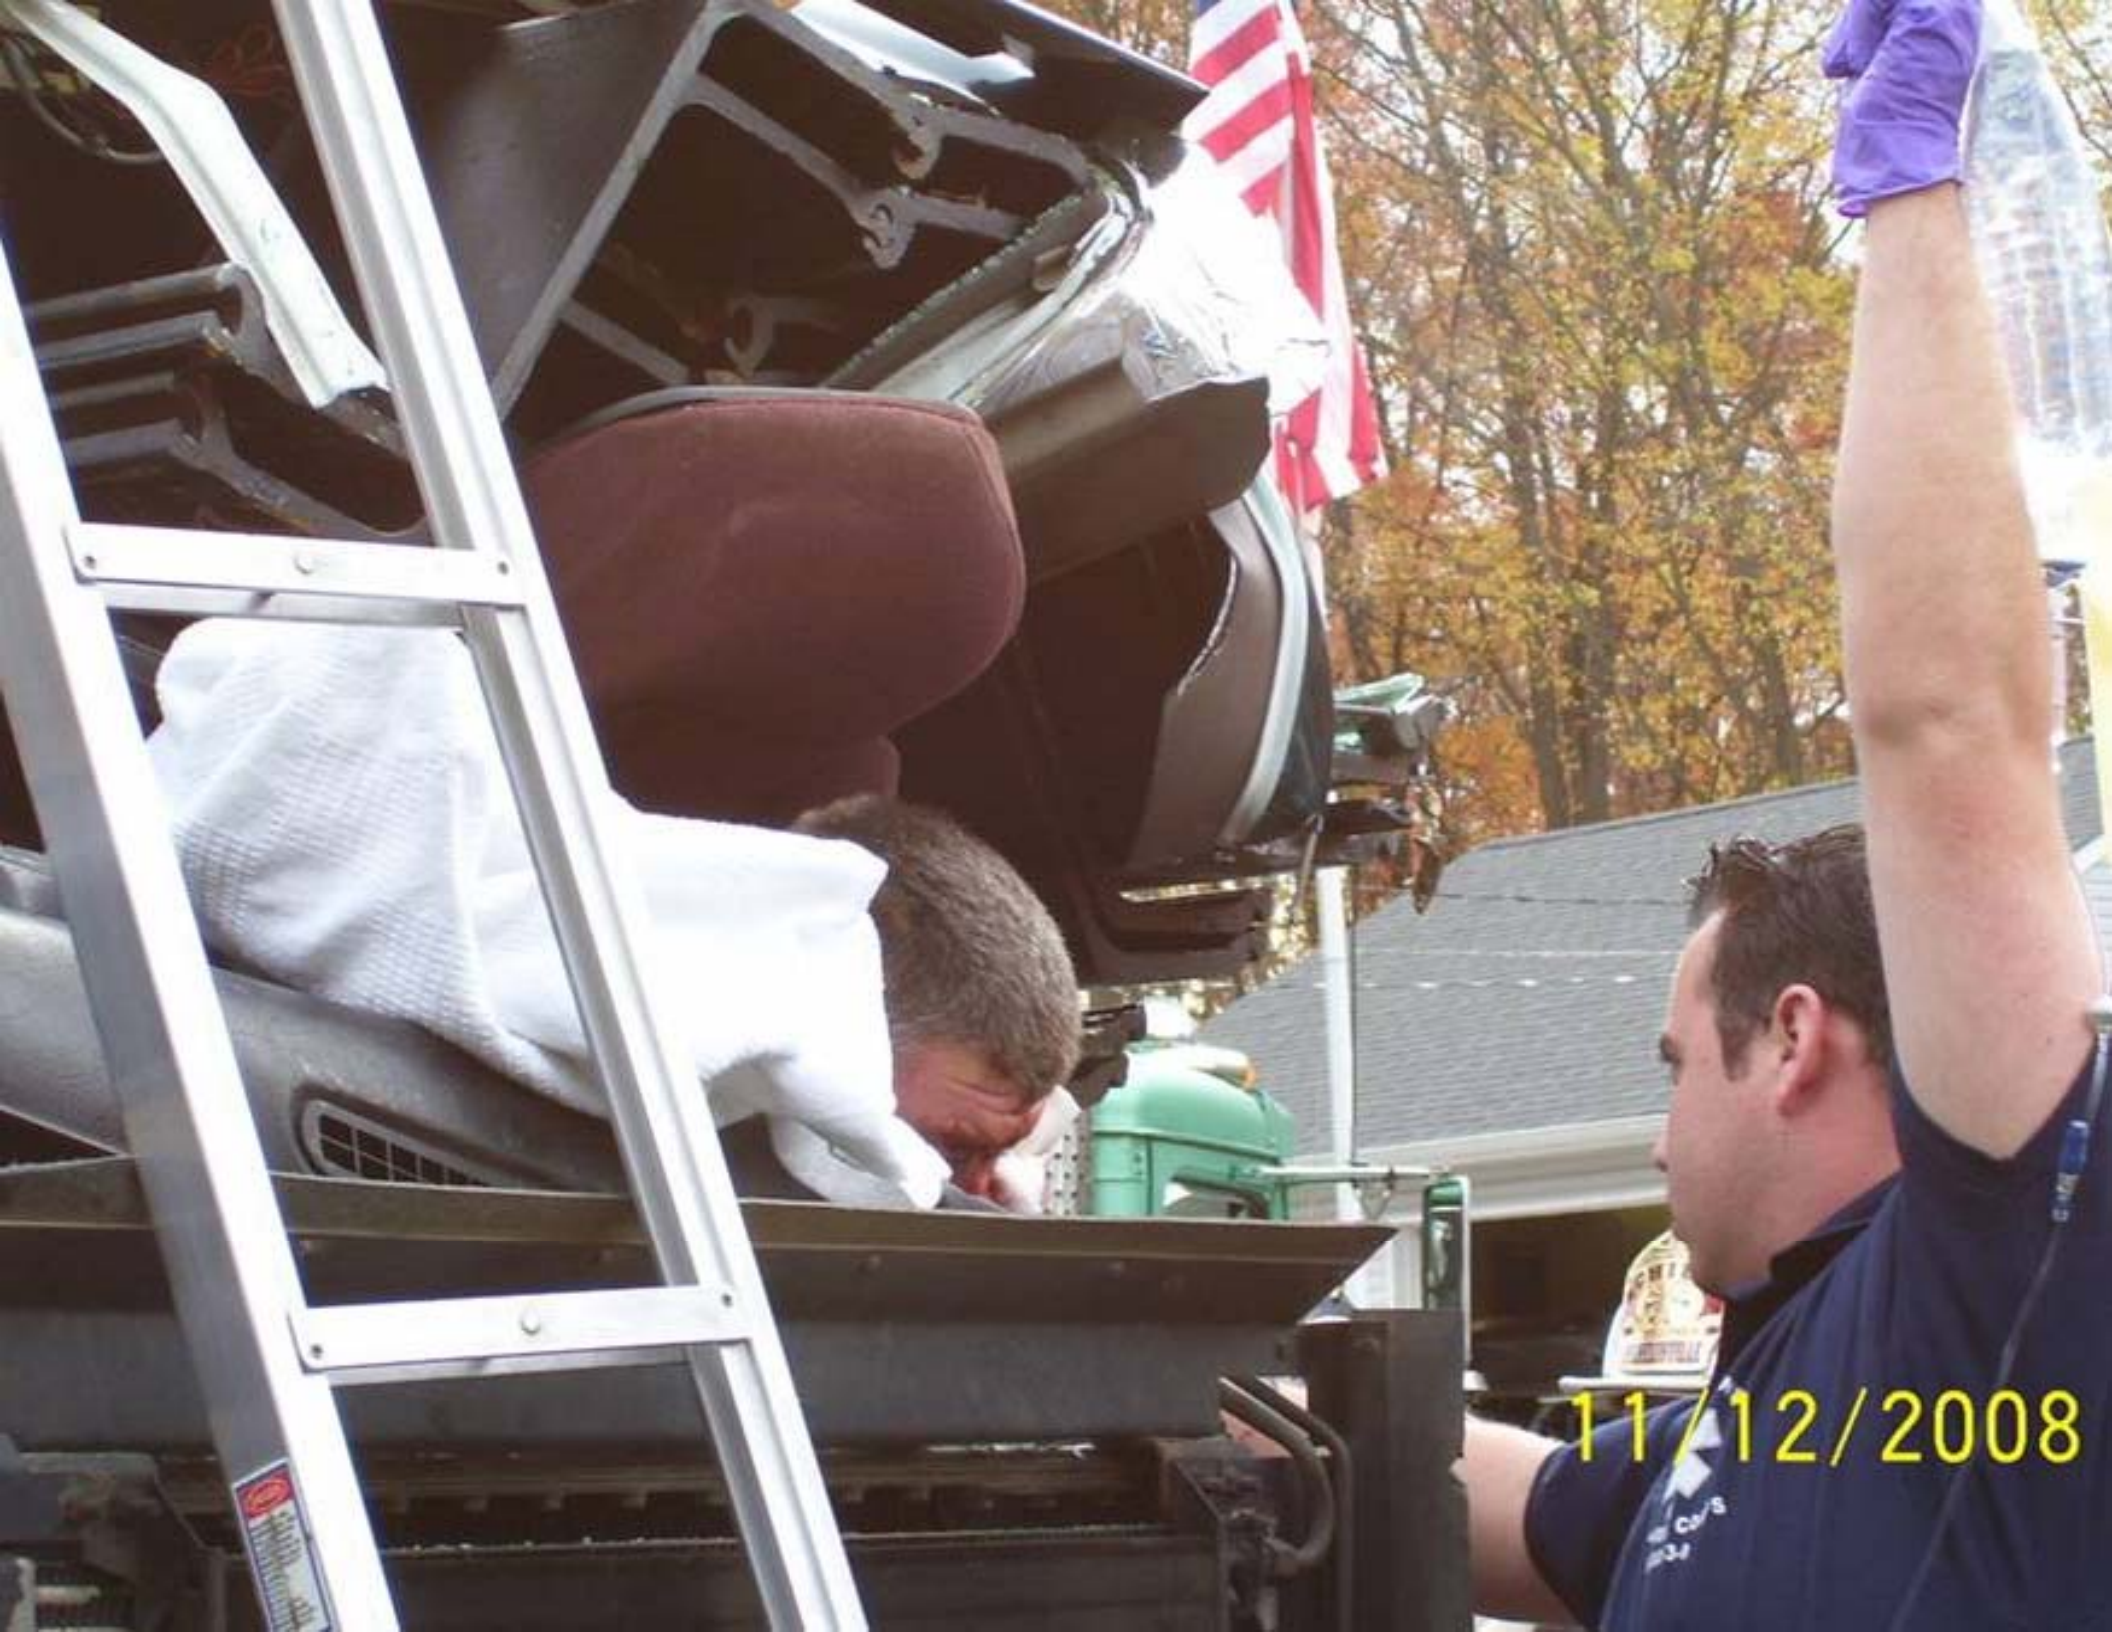
A 550 KVA generator set was being moved by a crane from a transport barge to the rig by connecting the lifting slings to the weatherizing framework. The frame pulled loose from the skid and the generator fell 15-20 feet (5 - to the deck destroying the generator set. Fortunately no one was under the load when it fell.

- The supervisor of the operation decided to perform the lift after lunch, but the crane operator and deck crew went ahead in an attempt to move the generator without the supervisor present.
- The lifting holes in the skid were burned in the bottom of the skid and not inspected.
- The barriers our company has erected to manage risk to an acceptable level failed. A competent person should have inspected the equipment and the lift points certified to an industry standard by a competent person.
- Due to the generator lifting points being cut in the bottom of the generator skid, the lifting shackles could not fit into the holes.
- The crew decided to tie onto the winterizing frame which failed during the lift.
- The frame was not inspected by a competent person for lifting purposes.
- When faced with a new safety issue, the crew did not STOP the job and review the process.

- The incident was shared with other company rigs and personnel. All rig supervisors were instructed to review the incident in their safety meetings.
- Rig personnel were instructed that tie-off lifting points are to be inspected by a competent person during construction.

- Personnel involved in lifting operations were instructed that they are to only use lifting points that have been certified by a competent person to lift loads. They were also instructed not use alternative points on equipment to lift equipment.

- Rig crews were instructed that when faced with a new situation the crew should have stopped the job and discussed changes (Management of Change) with their supervisor to ensure the job could be done safely.

- People faced with new safety concerns should STOP the job and review the concerns with their supervisor. Each employee has the authority to "STOP" the job, but no one did.

- All employees were reminded to use the barriers that the company has established to prevent incidents and take the lead on safety.
